Air Conditioning Validation

Project Address	-Withheld-
Client	-Withheld-
Date of Validation	-Withheld-
Equipment Manufacturer	Mitsubishi Electric

A Validation Survey was carried out to 8 Mitsubishi Electric VRF-Type Air Conditioning Systems serving 8 floors, on -date withheld-.

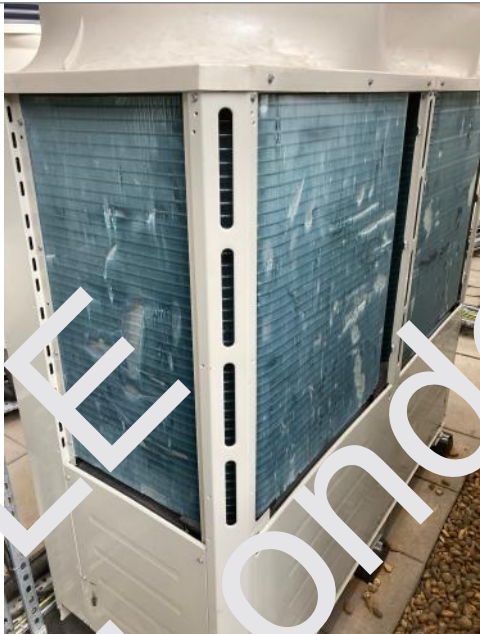
The majority of Fan Coil Units are in a generally damaged and poor condition with the exclusion of one Fan Coil Unit which has signs of previous water damage, as well as missing panel screws. On the contrary, the Condenser Units all have significant damage to the coils, which need to be addressed in the first instance. It was also noted that some pipework has been incorrectly insulated at roof level.

The 7th Floor Condenser Coil appears to be pierced and damaged beyond repair. This requires addressing urgently.

Condenser Unit coil damage

- Termination or replacement of all condensate drainage.
- Repairs to (or replacement of) Condenser Unit coils.
- Detail of total system refrigerant charges: these should be detailed on each Condenser Unit.
- Repairs to refrigerant pipework insulation where necessary.
- A full system maintenance.
- Full flood test of the drainage network to ensure water-tightness, with certification.
- Full system commissioning, with commissioning certificates issued for each system.

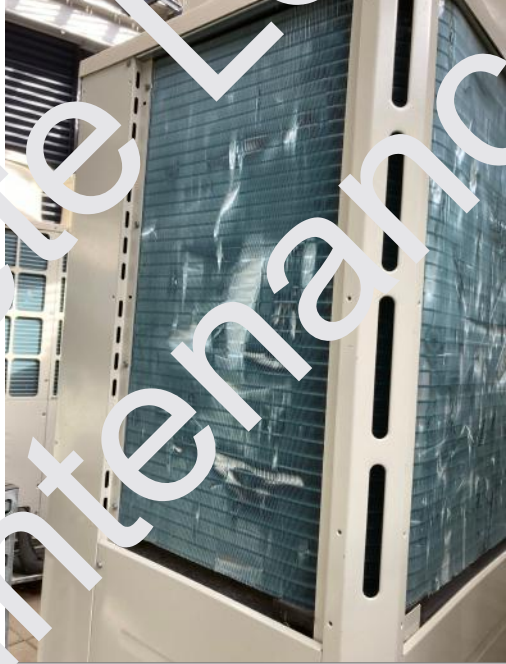
Condenser Unit coil damage continued

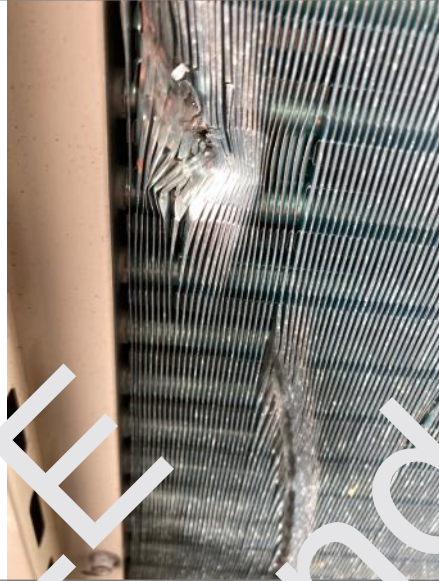
Condenser Unit coil damage continued

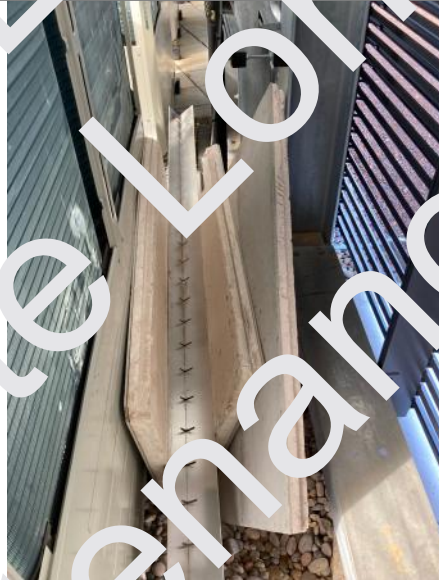
Debris around Condenser Units

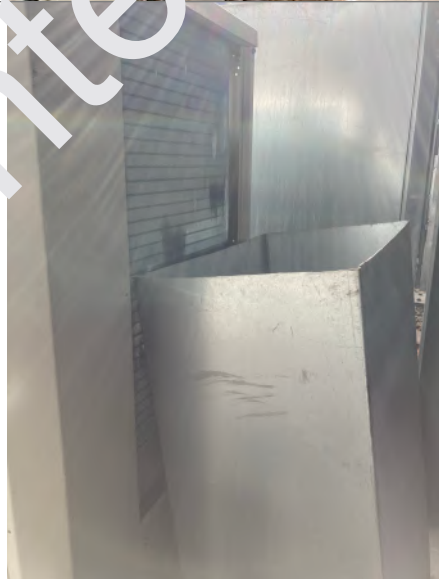
Debris around Condenser Units

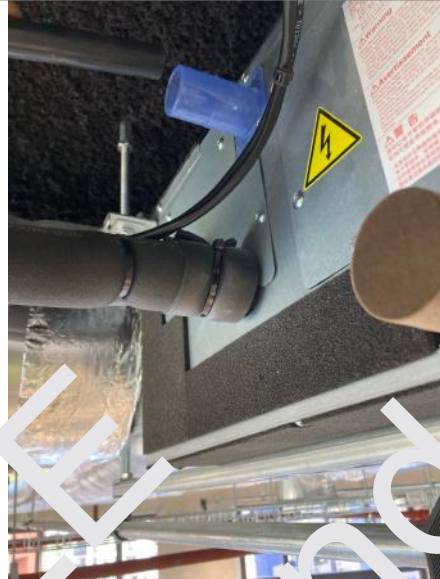
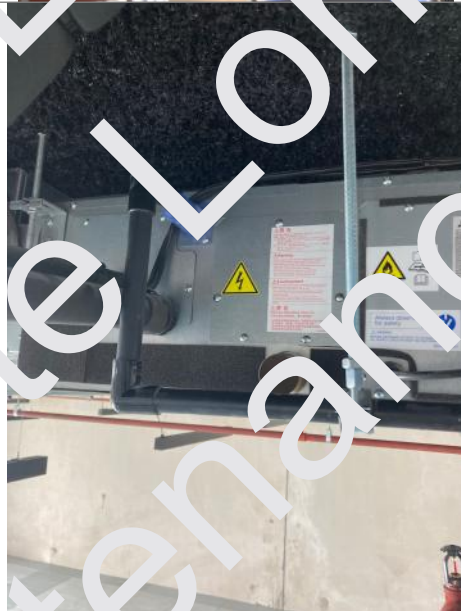
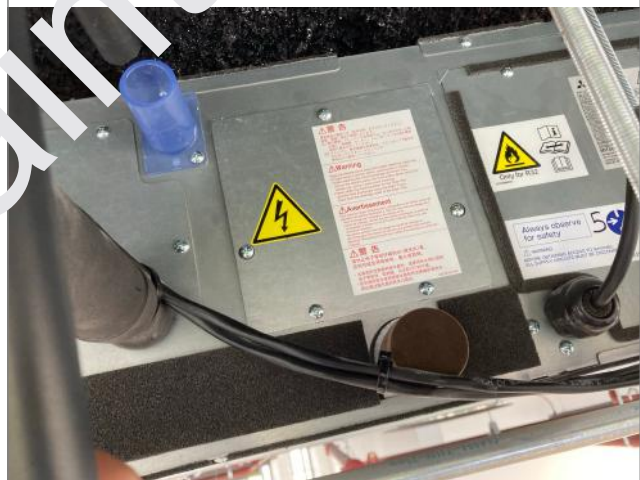
Condensate to Fan Coil Unit unfinished.

As above

- Service valves (ball valves) on all BC Control Boxes are not insulated.
- All Condenser Unit coils are significantly damaged.
- Fan Coil Unit condensate drainage has not been terminated across the entire building, excluding three units.

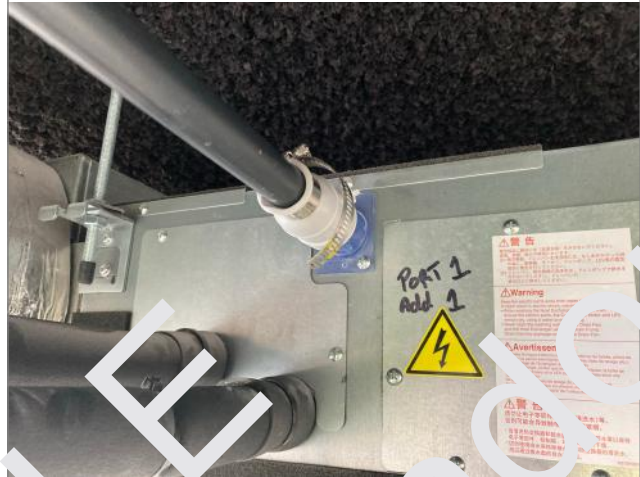
Where condensate drainage has been terminated, the incorrect size 'sock' adapter has been used. It is recommended that the correct size adaptor is installed.

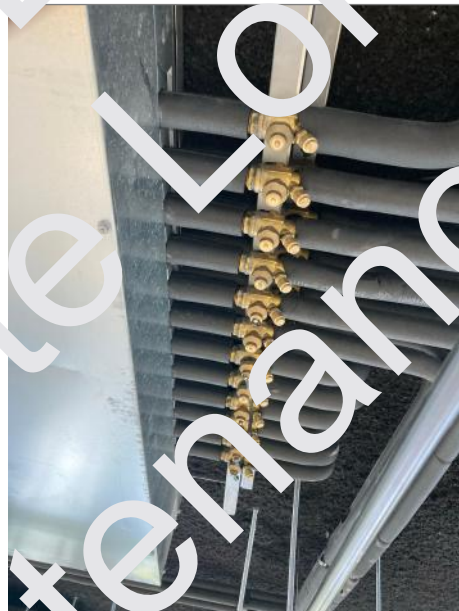
Uninsulated service valves to BC Control Boxes

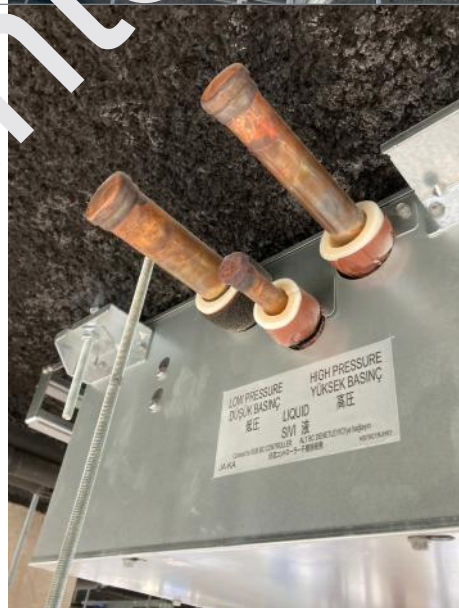
Uninsulated pipework at BC Control Boxes

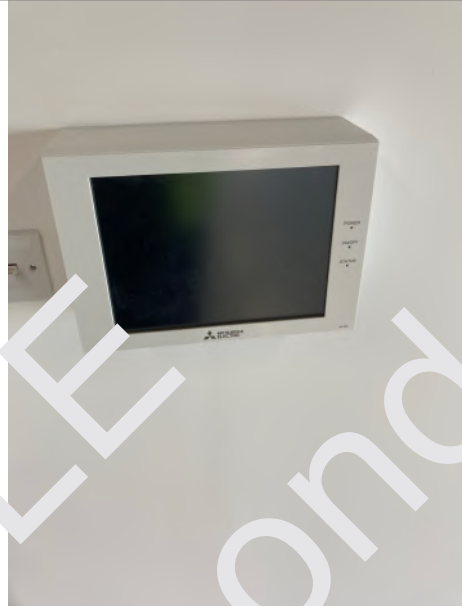
No power to AE200 (pictured: 5th Floor)

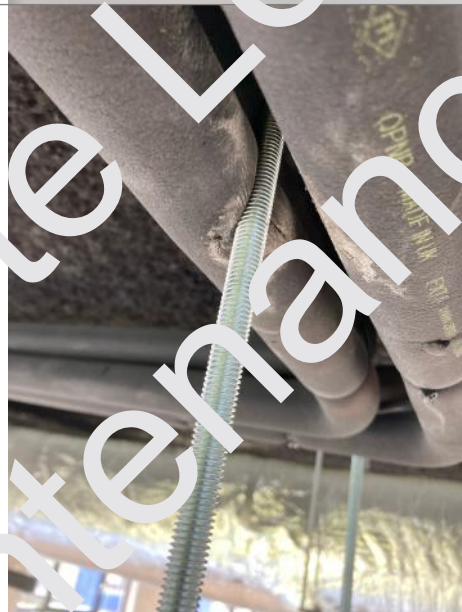
Metal drop rod is causing damage to pipework insulation.

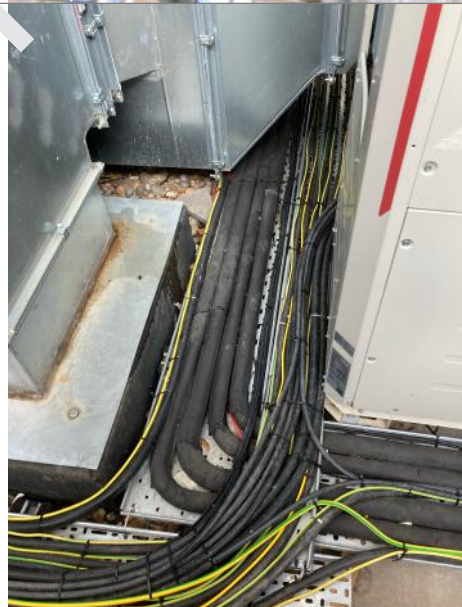
Large amount of insulation tape have been used to cover damaged insulation.

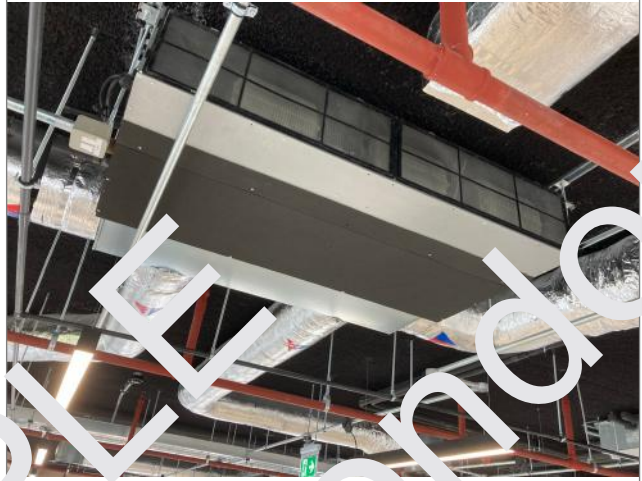
General cleanliness of the system is adequate, whilst Fan Coil Units are generally clean, return air filters are fairly heavily deposited.

Typical return air filter condition

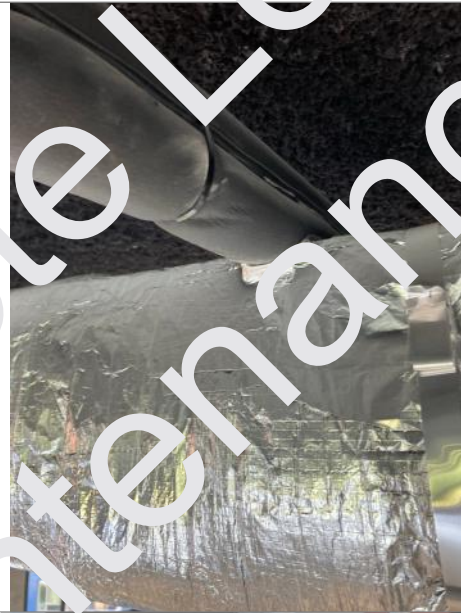
Pipework is resting on ductwork, damaging insulation.

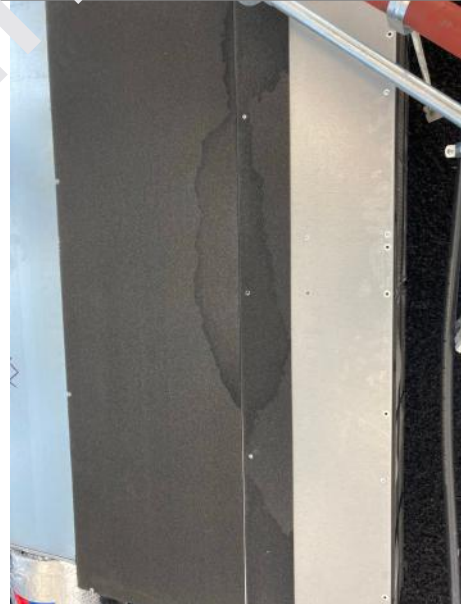
Signs of water damage on Fan Coil Unit.
